Table Rock Lake Lampe Resort

Presented as part of an extensive study and works project undertaken from 2001 to 2005 by Table Rock Lake Water Quality

Table Rock Lake
Lampe Resort

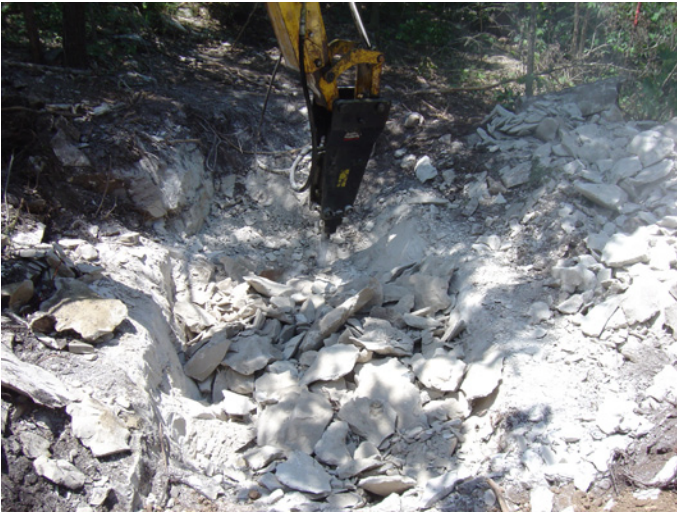
The property did not have a good soil base for the drip field. The drip field required that soil be imported to establish the needed base.

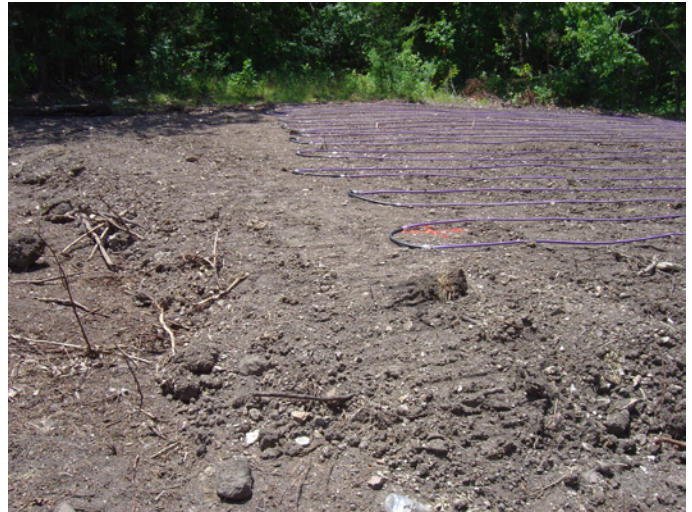
A good view of the imported base brought in for the field. Soil was brought onto the field in 4" - 6" lifts until an adequate base was established.

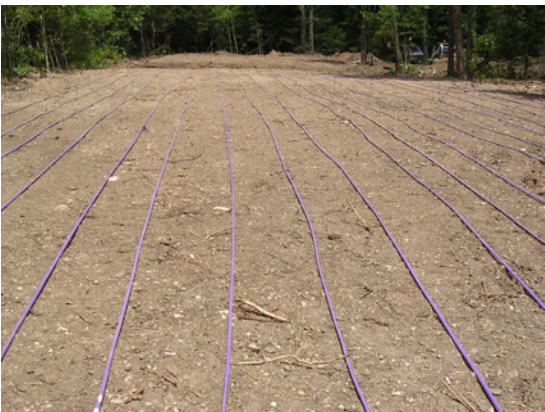
Netafim Bioline laid onto the imported soil in equally-spaced rows.

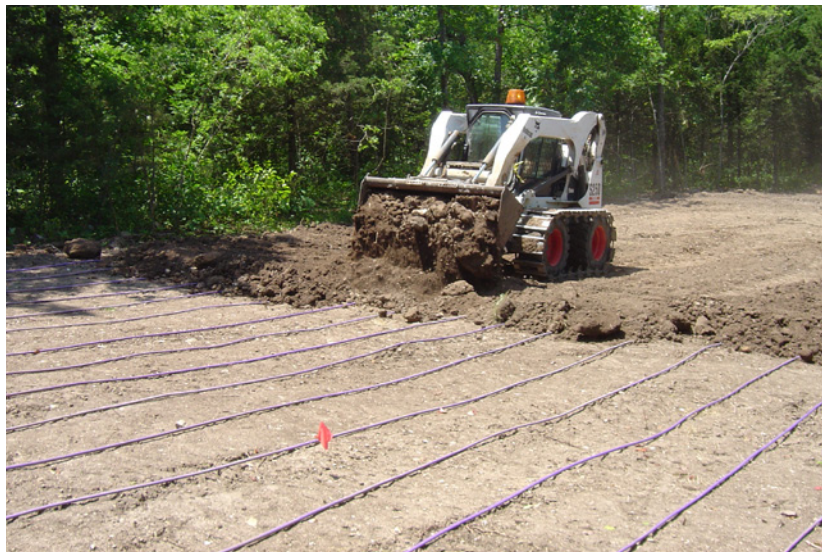
This photo shows the proper method for covering the dripperline in a 'drip and fill' application. The use of a track vehicle to provide a reduced weight footprint is important. As soil is brought onto the field, it is important to keep the vehicle moving with the dripperline to prevent it from shifting.

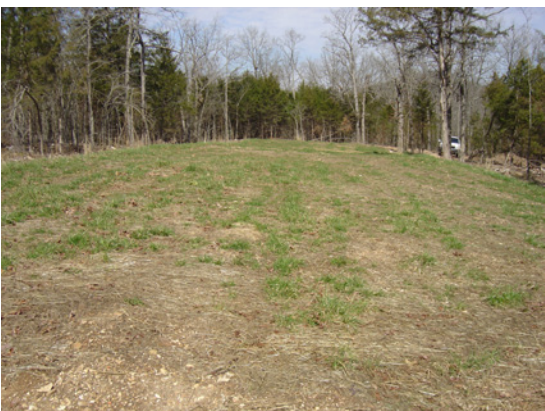
After installation and final cover of the Bioline, the drip field is ready for use by resort guests.
